# Post-seismic Effectiveness of the Strengthening Work Carried Out with GFRP Applied to Historical Masonry Buildings: The Case Study of the Spoleto Cathedral

Alessandro Grazzini<sup>1 (\*)</sup>, Stefano Agnetti<sup>2</sup>

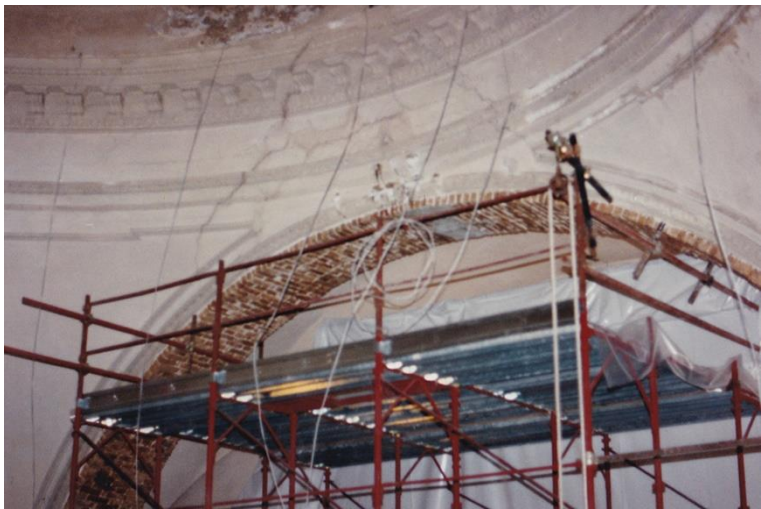
After the 1997 Umbria-Marche earthquake, the Spoleto Cathedral was subjected to a detailed survey carried out in order to know the actual conditions of the monument about the structural and security aspects. The non-homogeneous distribution of the damages present in the various parts of the cathedral showed a different behaviour towards the seismic actions. So the seismic events have highlighted the structural weaknesses, also amplified by the absence of maintenance. The façade showed widespread degradation, mainly due to water infiltration. The main aisle instead suffered cracks on the barrel vault following the seismic action. In the left aisle there were diagonal cracks with respect to the axis of the church in correspondence with the cross-vault centreline. In the area of the high altar there were instead cracks in correspondence of the triumphal arch near the apse (**Figure 8**). In this arc there were produced deep cracks and tilted both in key and in the kidneys which produced a detachment of the central part of the arch up to the dome's turn. In the left transept there was a detachment between the barrel vault and the stiffening arches. The most serious damage occurred in the Chapel

**Figure 8.** The cracks of the triumphal arch of the main nave.

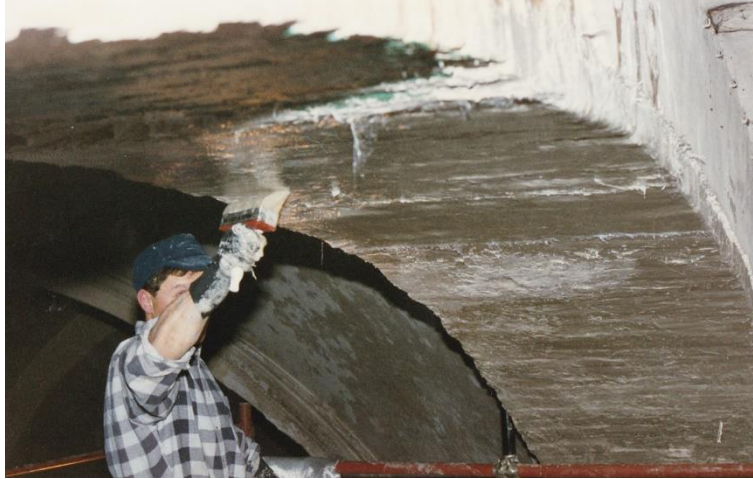
**Figure 12.** Application on the treated surface of two-component synthetic resin primer in aqueous dispersion.

primer. First of all, application on the treated surface of two-component synthetic resin primer in aqueous dispersion (**Figure 12**). Subsequent application of solvent-free two-component thixotropic epoxy adhesive (**Figure 13**).

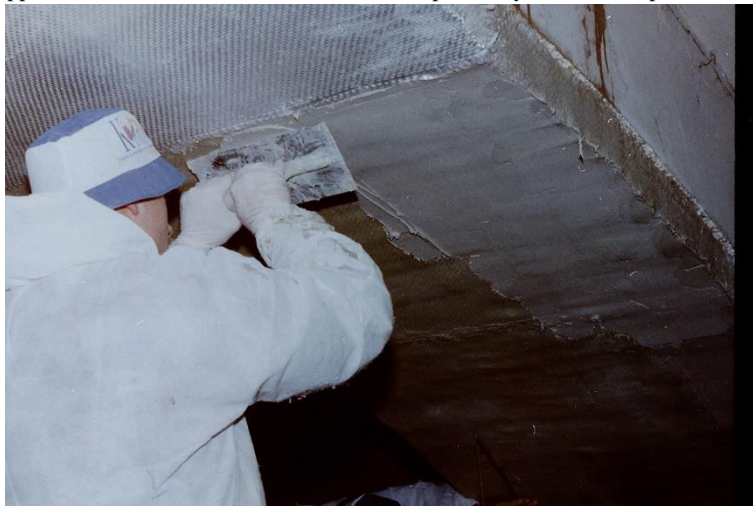
**Figure 13.** Application of solvent-free two-component thixotropic epoxy adhesive.

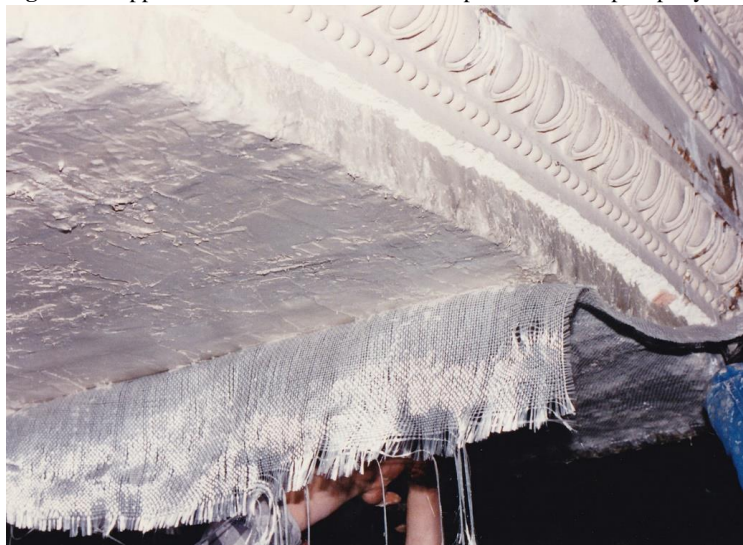
**Figure 14.** Intrados application of GFRP band for strengthening arch.

The product had the function of levelling the surface to be reinforced and creating an adhesive layer for the subsequent application of the reinforcement. The application of the fabric occurred in the fresh air, applying fibre bands with an iron roller and exert a slight pressure, taking care not to create air bubbles (**Figure 14**). The fabric was pressed in the resin layer, using the roll for composites (always roll in the direction of the fibers, exerting slight pressure paying attention not to move the fabric during this phase). It was necessary to roll until the resin emerges between the fibers and impregnates them completely, forming a uniform layer on the fabric. It was very important to remove any air bubbles that may be trapped between the fabric and the substrate, continuing to roll in the direction of the fibers. Subsequent impregnation with solvent-free, two-component, fluid-containing epoxy resin applied by brush or roller in several coats and slowly so that the impregnation of the fabric was complete. Any further reinforcement layers should be applied fresh on fresh and immediately impregnated with resin.

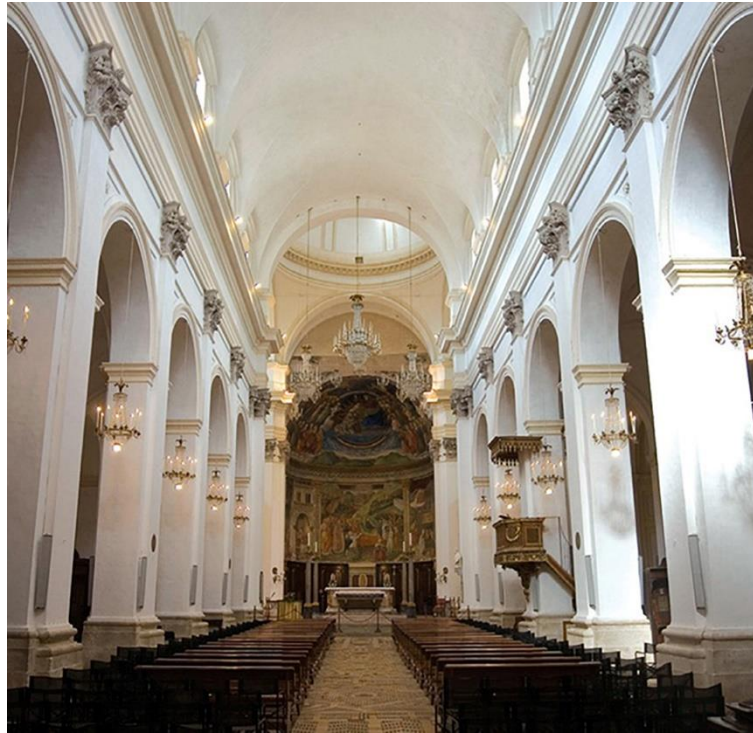
Thanks to this series of structural reinforced work, during the 2016 Amatrice-Norcia earthquake the Spoleto Cathedral has not suffered any damage confirming the seismic improvement achieved (**Figure 15**).

**Figure 15.** The interior of the Cathedral today after the safety work and after the 2016 Amatrice-Norcia earthquake.
